# GROUTING AGAINST I&I

Orange County takes a joint-specific approach to reducing inflow and infiltration

By Giles Lambertson

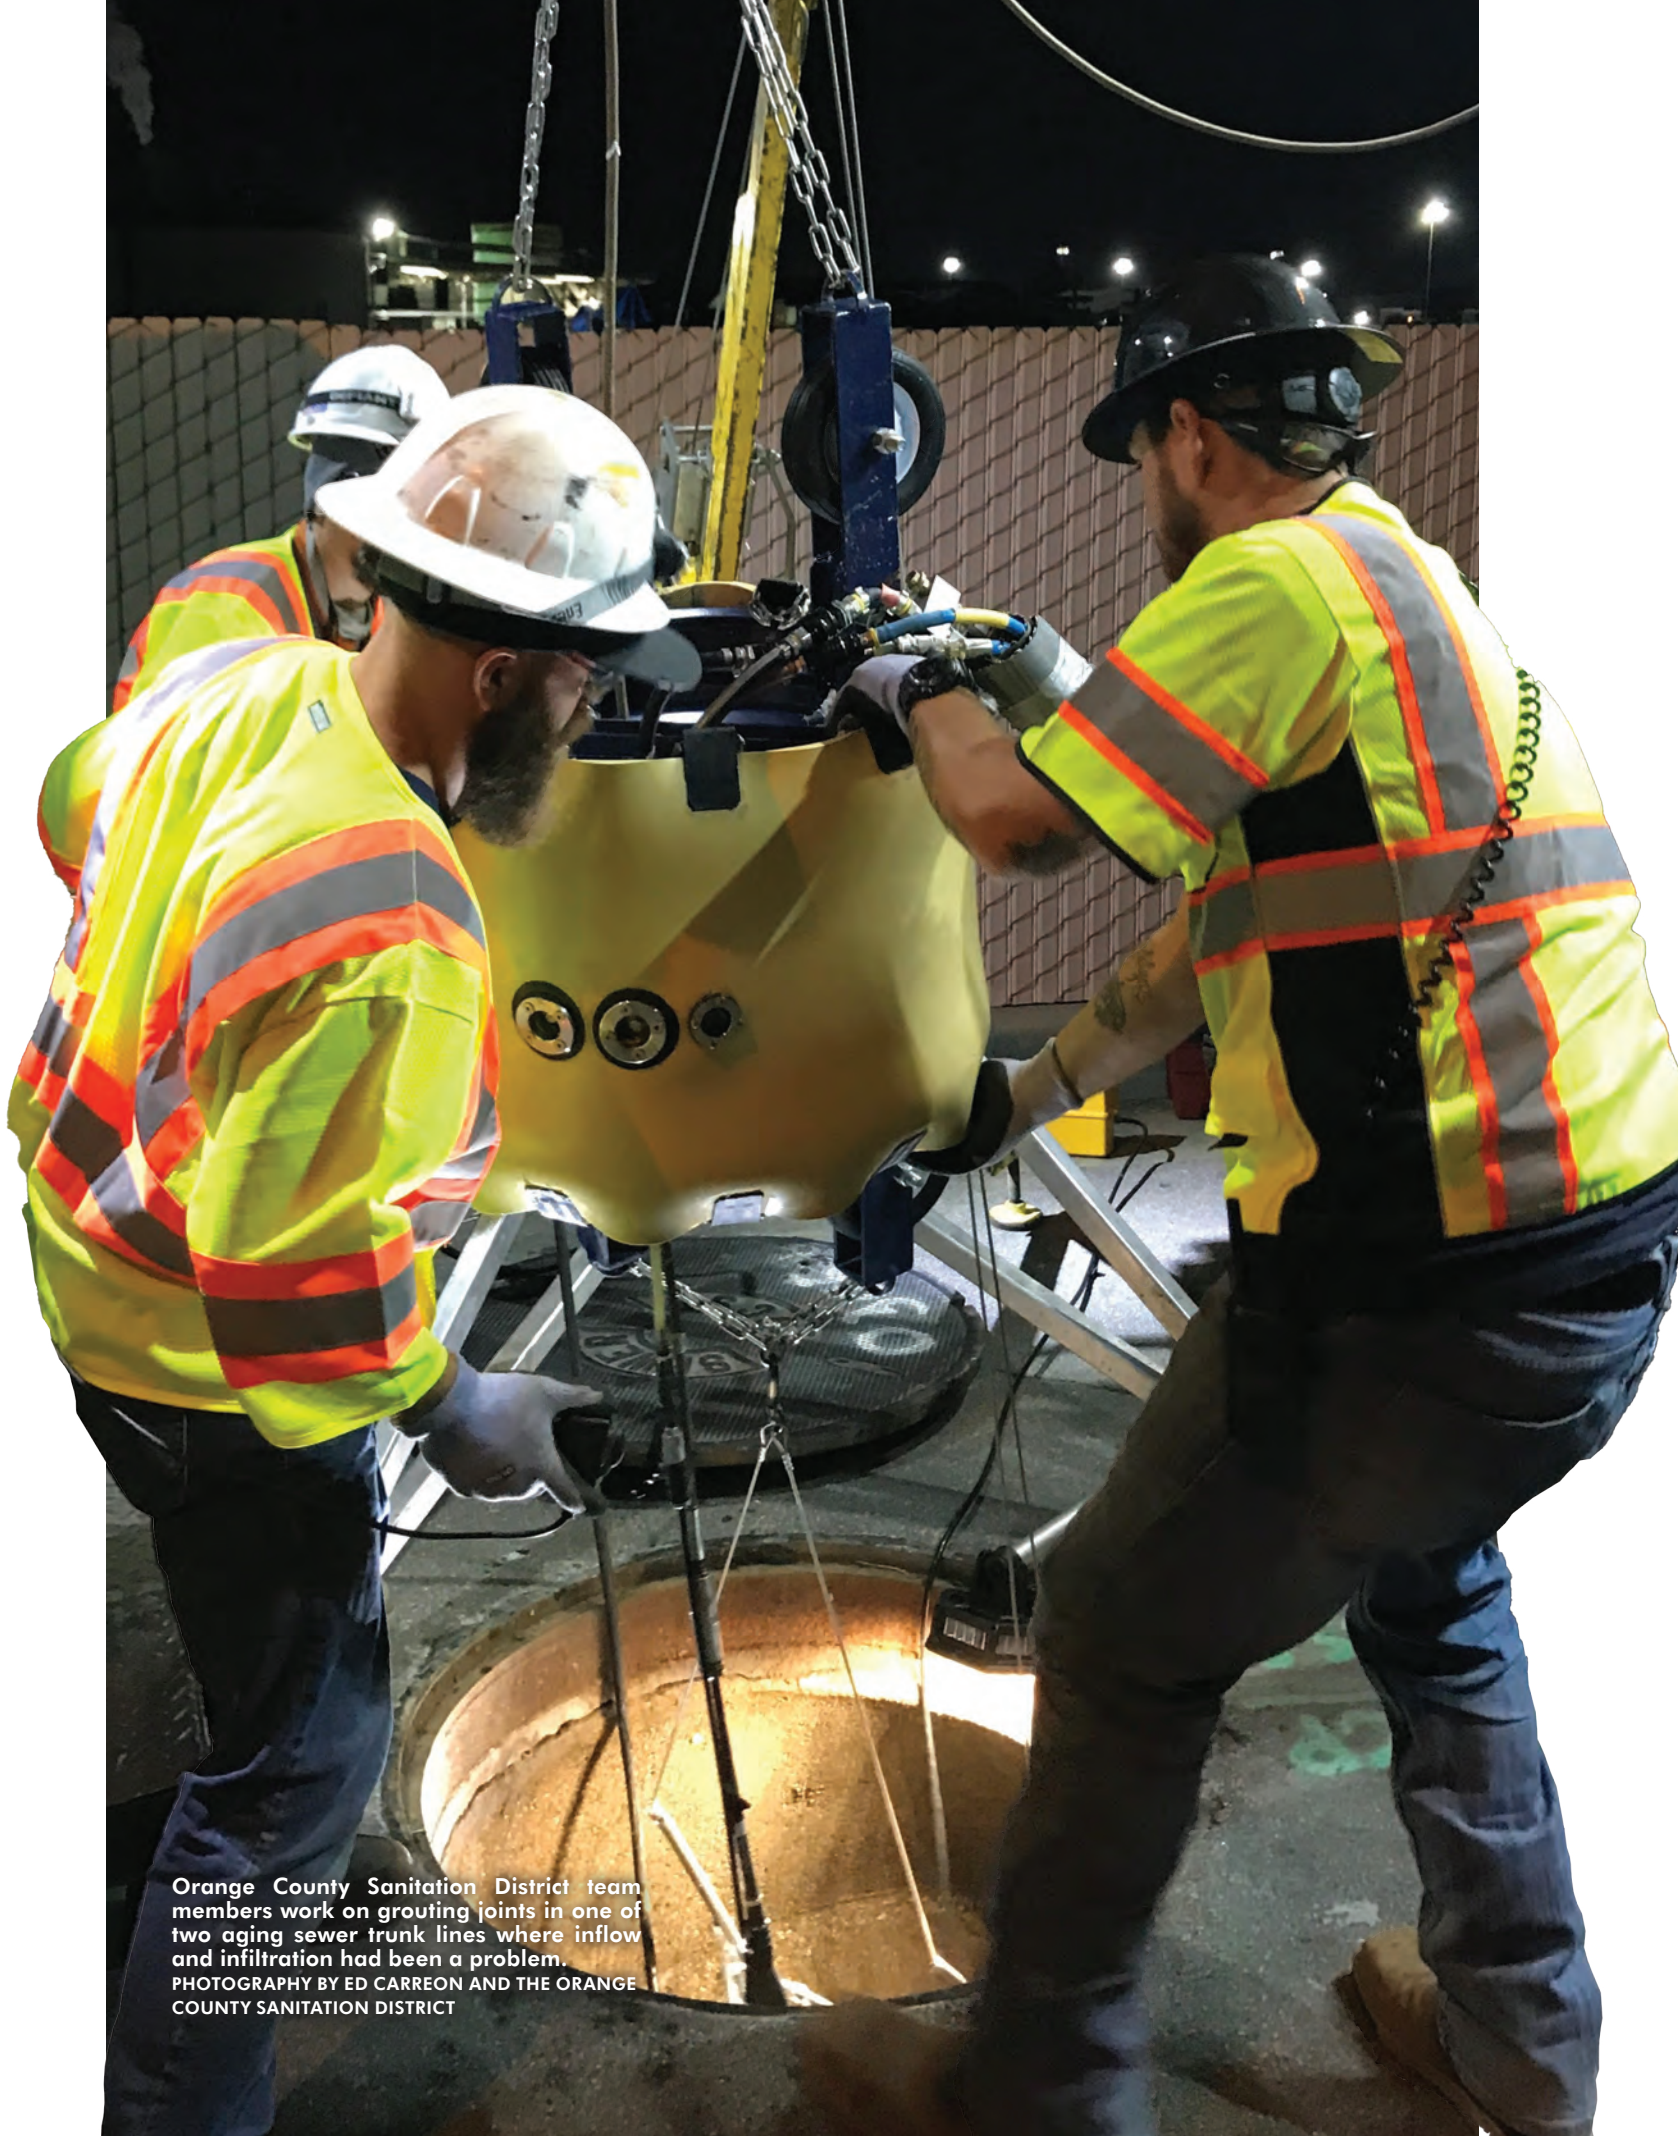
Orange County Sanitation District team members work on grouting joints in one of two aging sewer trunk lines where inflow and infiltration had been a problem.  
PHOTOGRAPHY BY ED CARREON AND THE ORANGE COUNTY SANITATION DISTRICT

The project began by putting each joint under 10 psi of air pressure, with the requirement that the joint sustain the pressure for at least 30 seconds. "If the joint passed, it received no grout. If it failed, we injected grout and retested," Fernández says of the process.

If a joint failed to hold pressure after being grouted, more grout was injected until it passed the air pressure test. Overall, the 1959 pipe had far more joints failing the air pressure test — 2,043 to the newer pipe's 336.

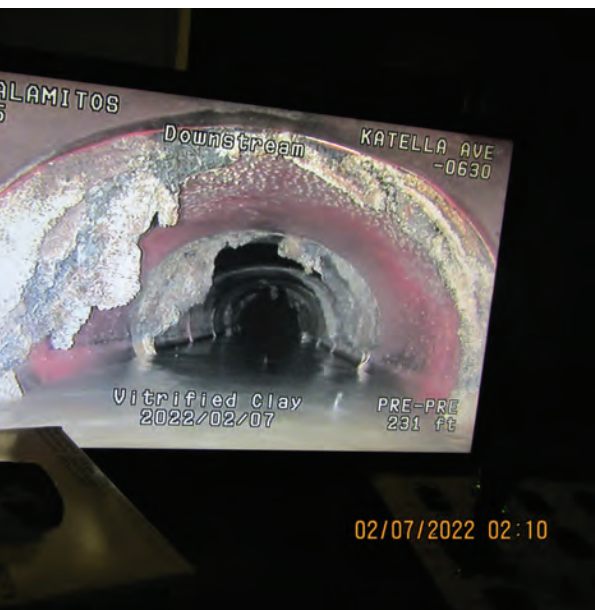
How could that be? Calcium. When the older pipe joints failed dramatically, calcium deposits clogged the joints and protruded into the interior of the pipe. Though precleaning of the pipe had removed the visible buildup of calcium inside the pipe, the jetting or robotic cutting did not extend into the joints themselves. Consequently, the same calcium that announced failure of a joint also partly filled the joints and became part of the sealing solution.

“We needed to inject less grout into the cracks to seal them because the calcium already was there,” Fernández says. The reverse was true in the newer pipe: There, the absence of calcium buildup meant that some failed joints required quite a lot more grout. In fact, 28 of those joints each needed 20 gallons or more to seal. Seven of them required 40 gallons or more.
